Replacement of the mastfoot
Omega 34/Snekkja, Owner: Arne Steinström

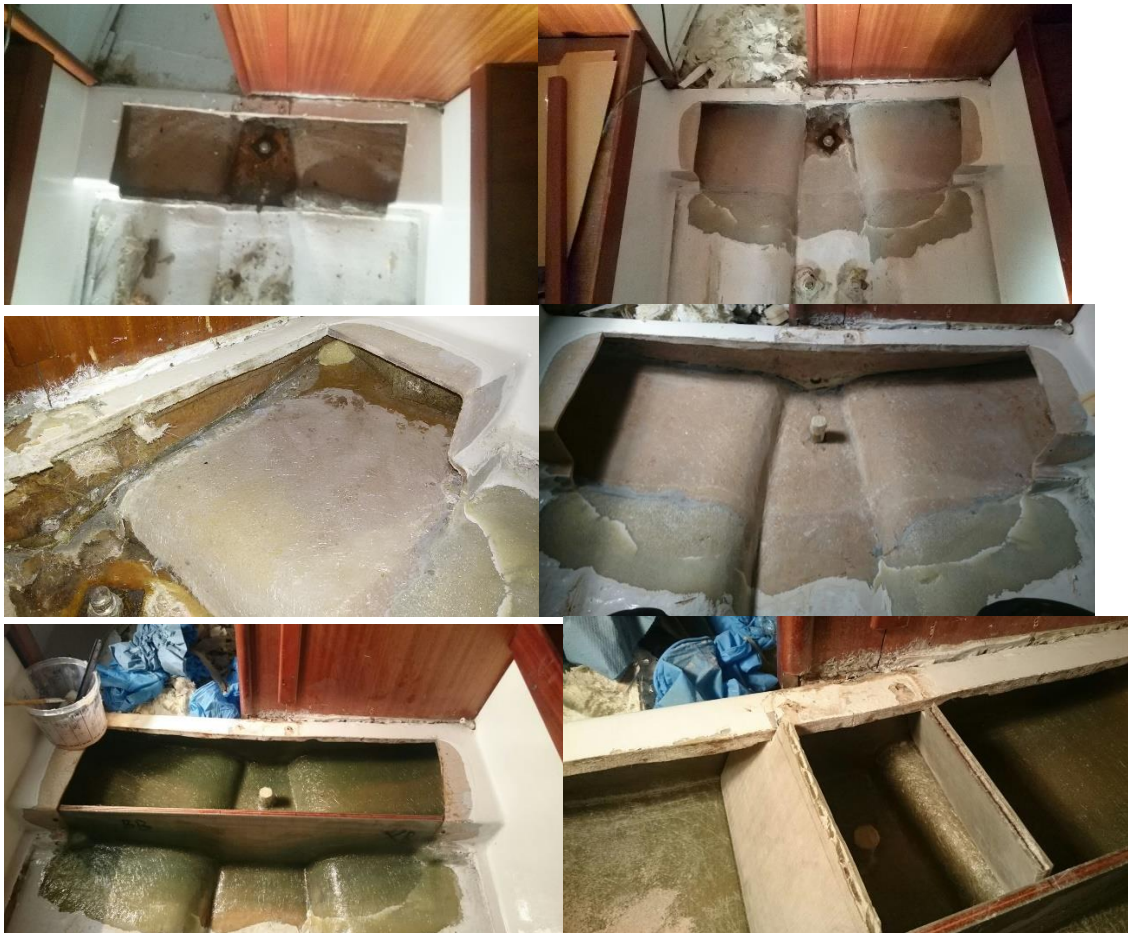
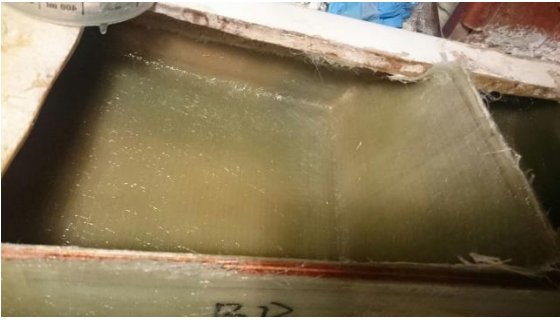
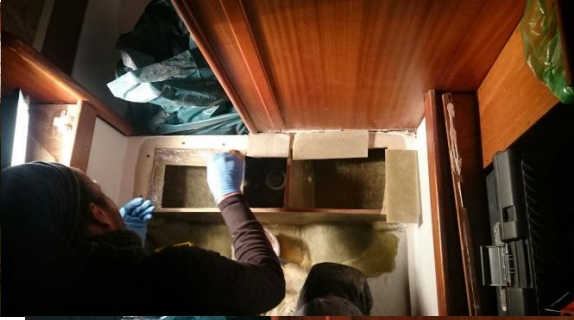
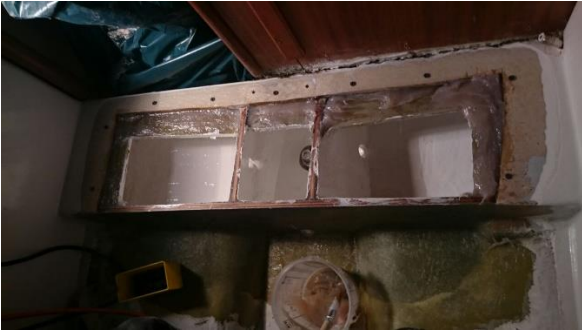
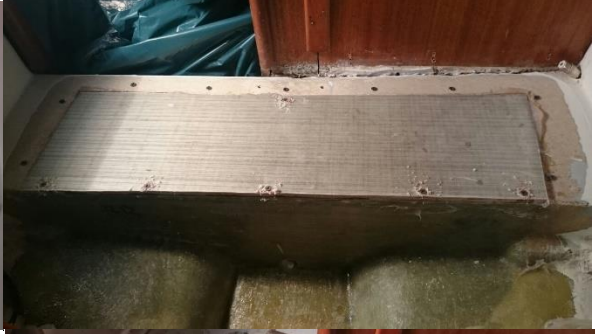
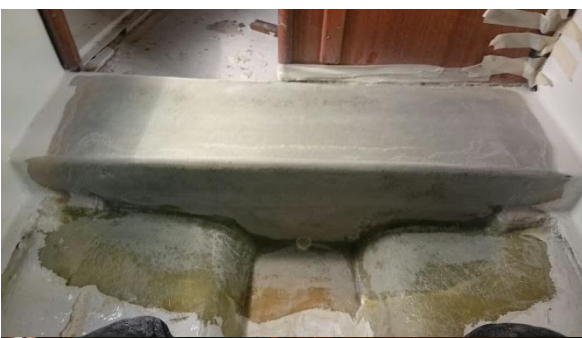
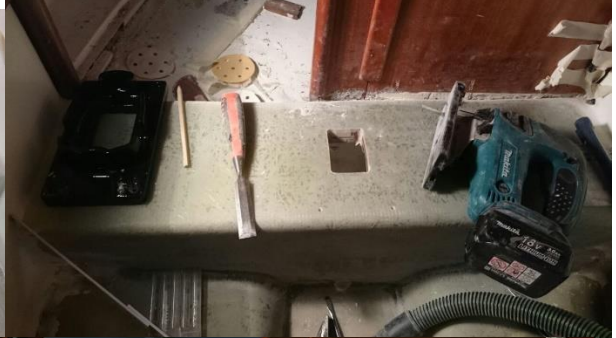
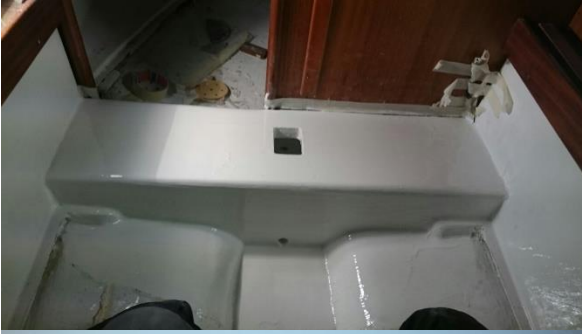
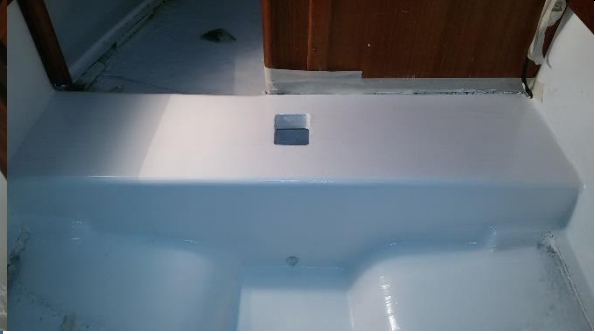
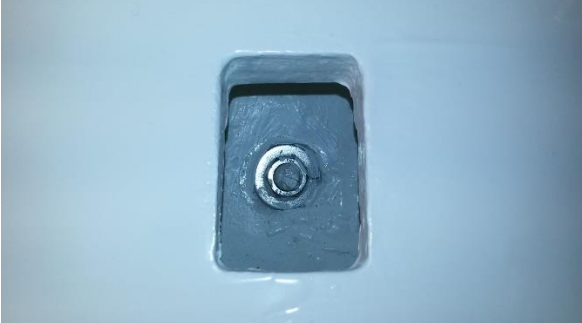
Our Omega 34 was built in 1986. In the last years we observed that the construction of the mastfoot got less stable. The yard had only laminated foot reinforcements underside of the mast in the inner shell of the hull which did not correspond with the force line of the mast. The result was, that the whole construction distorted under load and hair crackings appeared at this place. First attempts of repair work some years ago from the outside did not improve.

In last winter, the decision was made for a large-area repair and replacement of the component. The transverse beam on which the mast stands had been opened. The underlying laminate was cleaned from the foam and laminate residues of the inner shell. The hull-laminate was then reinforced and as well new reinforcements where built in the force line of the mast. These have now connection to the hull and the inner shell. Afterwards the transverse beam was closed from the top with a slab of 35 mm water resist plywood and finally the whole component was laminated several times.

Although the outer dimensions of the transverse beam have not been changed, the rigg is now approx. 2.5 cm higher than before. Even with rigg trimmed to 20% breaking load of the shrouds, no appreciable deflection of the trunk in the area of the main bulkhead was observed.
